Powerglide Linkage Adjustment

Overdrive Governor Water Leakage

Air Cleaner Gasket Installation

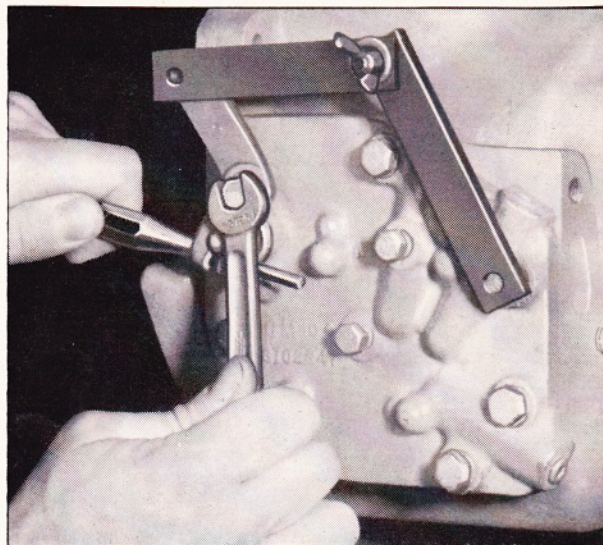
Fig. 8

A change has been made in the angle of the transmission throttle valve control outer lever and in the length of the control rod to lower the part throttle upshift range to 12-18 MPH on 1955

Powerglide six cylinder passenger car models. This will necessitate revising the present linkage adjustment procedure at the low and drive valve body where the new outer lever and control rod are used.

1. With the control rod disconnected from the lever, remove the top bolt and lockwasher on rear edge of low and drive valve body cover.
2. Loosen the outer lever adjusting bolt.
3. Remove the outer lever assembly clamp bolt and install a suitable tool through the clamp bolt slot to assist in rotating the lever.
4. With the throttle valve outer lever positioning gauge J-5906 set at 6", rotate the outer lever counterclockwise to permit the gauge to be installed in top bolt hole and lever. Install gauge as shown in Figure 8.
5. With the clamp and outer lever rotated counterclockwise to the open throttle position (to a definite stop), tighten adjusting screw (fig. 8).

In cases where the six cylinder Powerglide units upshift in the 26-28 MPH range on part throttle, and it is desirable to have the upshift at 12-18 MPH for the best fuel economy, particularly in metropolitan areas, the new outer lever and control rod should be installed.

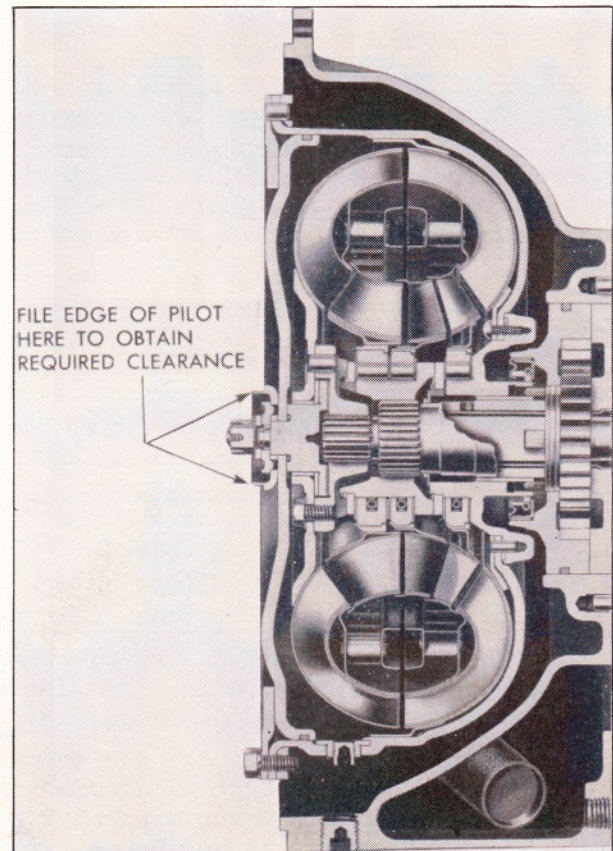
Figure 1

In cases where interference is encountered between the cover pilot and the crankshaft when installing a service crankshaft on 1950-52 Powerglide models, a slight rework will provide the necessary clearance. Clearance may be obtained by filing the edge of the pilot as indicated in Figure 1.

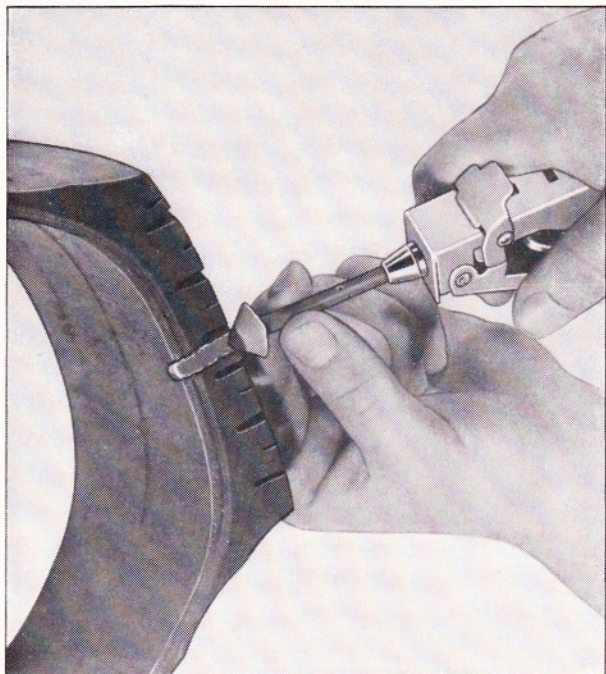
Fig. 11—Starting Plug into Puncture

Lubricate head of plug with rubber cement. Place plug head over puncture hole—holding lower end of metal tube to guide it and prevent bending—and push the entire metal tube

into the puncture hole up to the base of the nozzle (fig. 11). Now press red spring stopper and squeeze the balance of cement into the tire (fig. 12). Retract metal tube with continuous clockwise turning and pulling action (fig. 13). Do not pull, but trim off excess of rubber plug protruding from puncture. The repair is now complete and the tire is ready for immediate use.

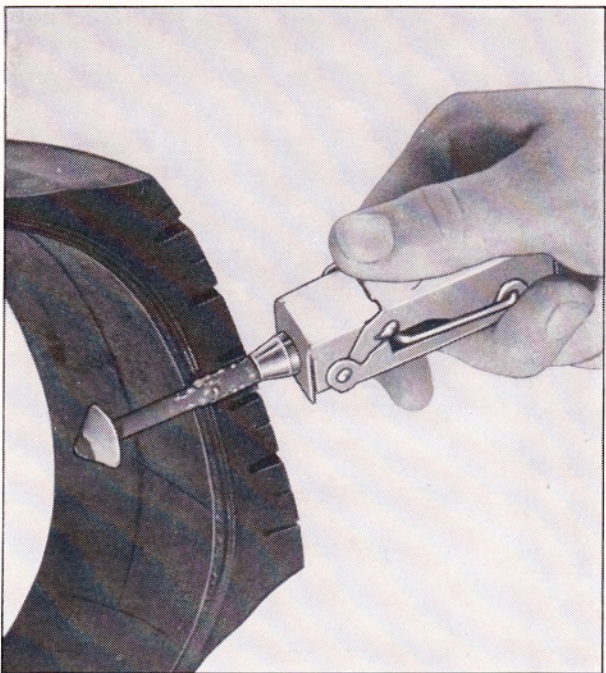
Fig. 12—Applying Remainder of Cement with Plug Inserted

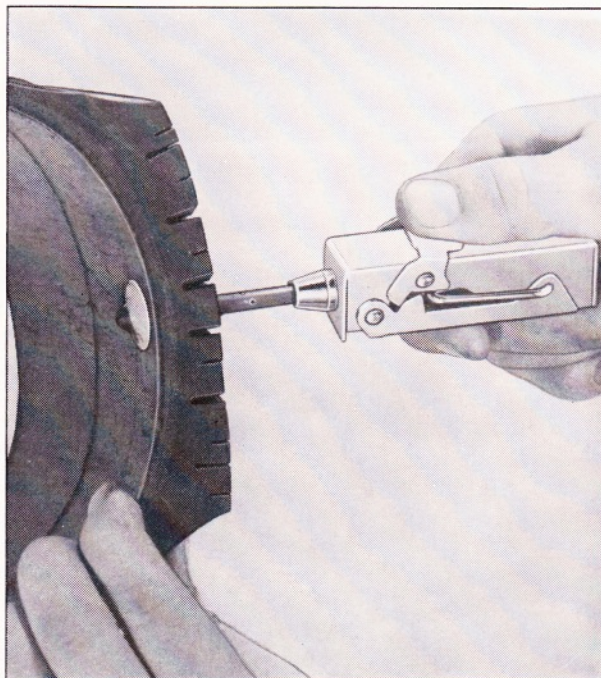
Fig. 13—Seating Plug to Complete Repair

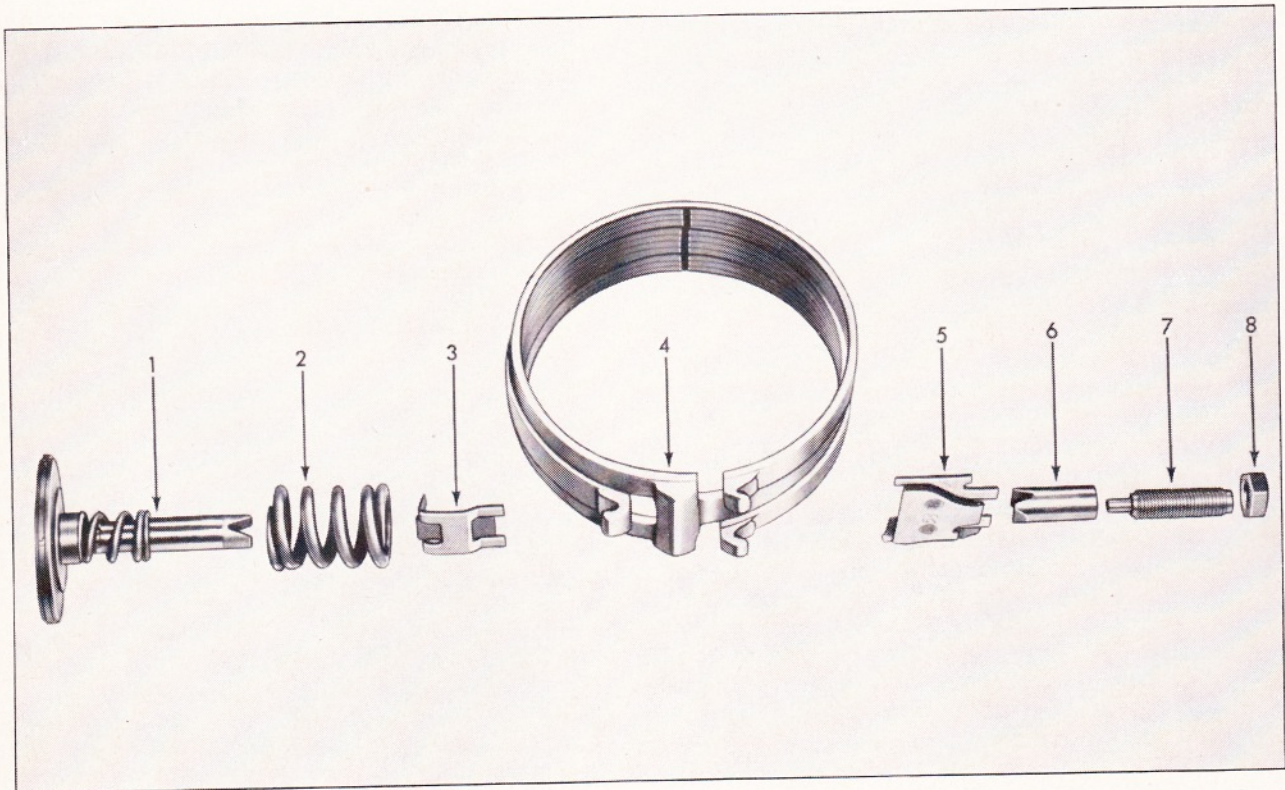
Figure 9

Improper installation of the Powerglide low brake band anchor strut (5, fig. 9) will limit movement of the band.

Service personnel are cautioned that the guide stamping of the anchor strut assembly must be installed *toward* the band as illustrated. This same illustration is carried as figure 86 in Section 7 of both the 1955 and 1957 Passenger Car Shop Manuals.
